HOME INSPECTION REPORT

123 New Home Lane, Atlanta, Georgia 30303

October 1, 2007

ABC Home Inspections, LLC.

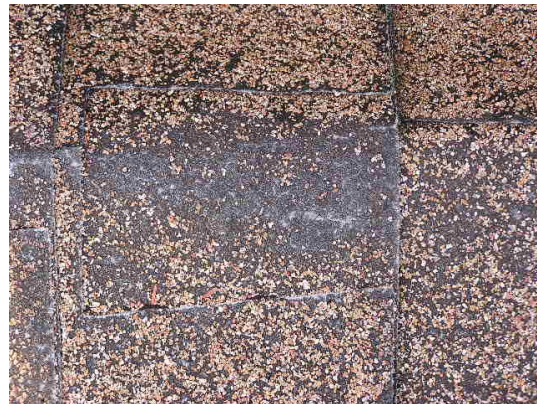
Roof was in poor condition and will need repair and/or replacement soon. Damaged boot flashings around the plumbing vents should be replaced as needed.

Roof: The main dwelling and garage roofs are in poor condition and will need repair and/or replacement soon. See photo on page 7.

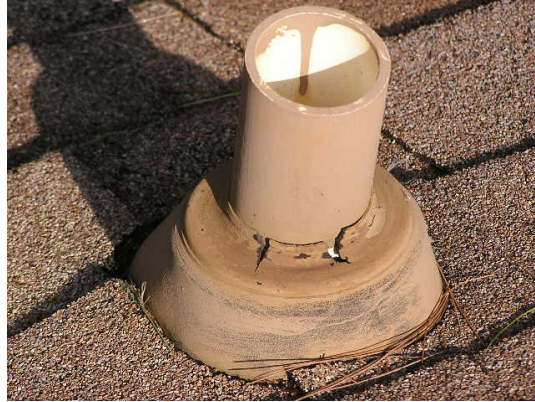
ROOF: Damaged boot flashings around the plumbing vents should be replaced as needed. See photo page 6.

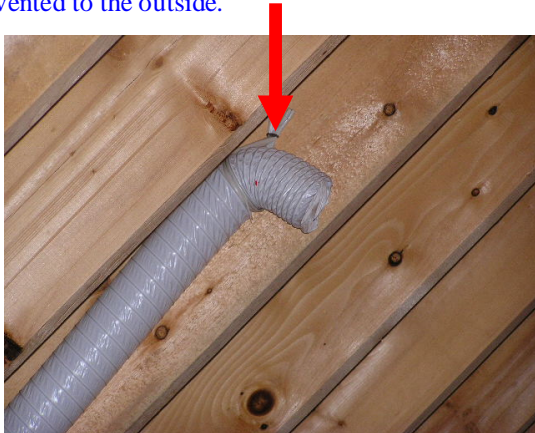
FAUCET/PIPES: The Master bath sink faucet is leaking - recommend repair and/or replacement as necessary. **EXHAUST:** Bathroom exhaust fans should be vented to the outside.

FAUCET/PIPES: The Master bath sink faucet is leaking - recommend repair and/or replacement as necessary.

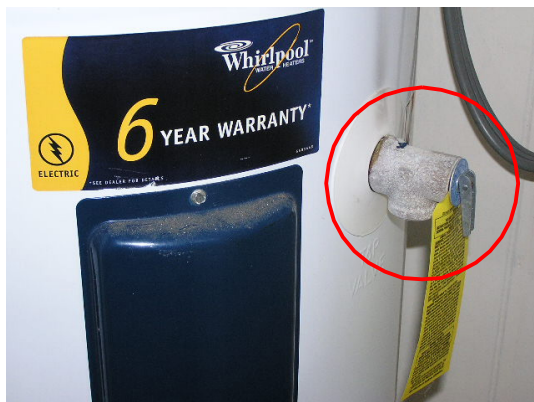
WATER HEATER: The temperature-Pressure relief valve discharge piping is missing, and should be installed to discharge within 4"-6" off of the floor, or to the exterior - this is a Safety Concern. The water heater is a 15 year old unit and is nearing the end of its typical service life. Client should budget for replacement.

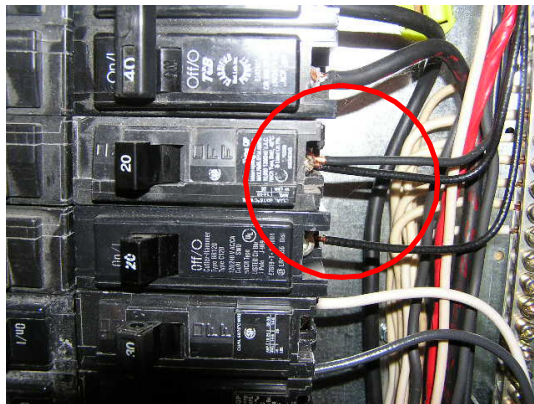
Double tapped circuits on the 20 amp breaker should be repaired by a qualified electrician.

ELECTRICAL: Double tapped circuits on the 20 amp breaker should be repaired by a qualified electrician. See photo on page 22.
